FARMINGTON RIVER BASIN
HARWINTON, CONNECTICUT

**BRISTOL RESERVOIR NO.4 DAM
CT 00364**

**PHASE I INSPECTION REPORT
NATIONAL DAM INSPECTION PROGRAM**

JUNE 1981

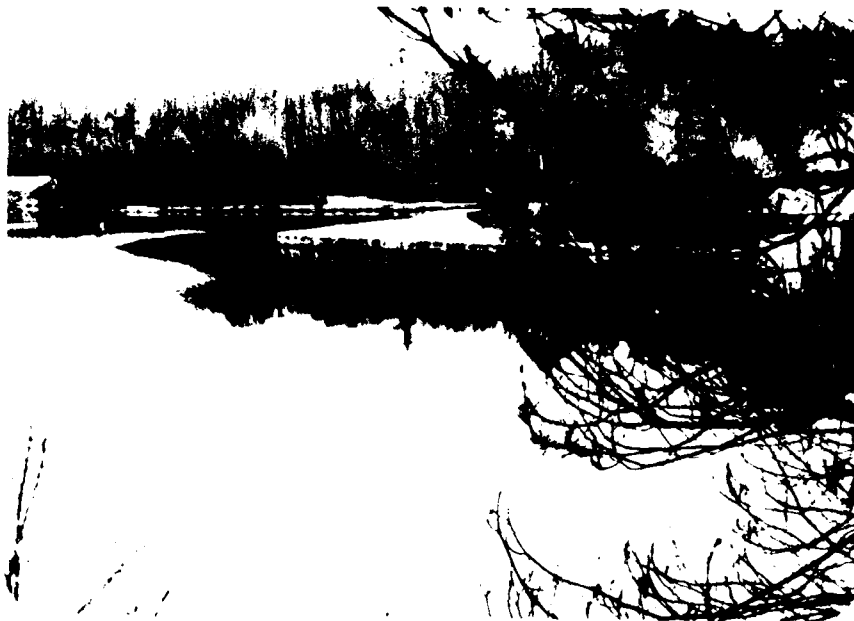
PHOTO NO. 1

OVERVIEW OF UPSTREAM FACE OF DAM
FROM RIGHT ABUTMENT.

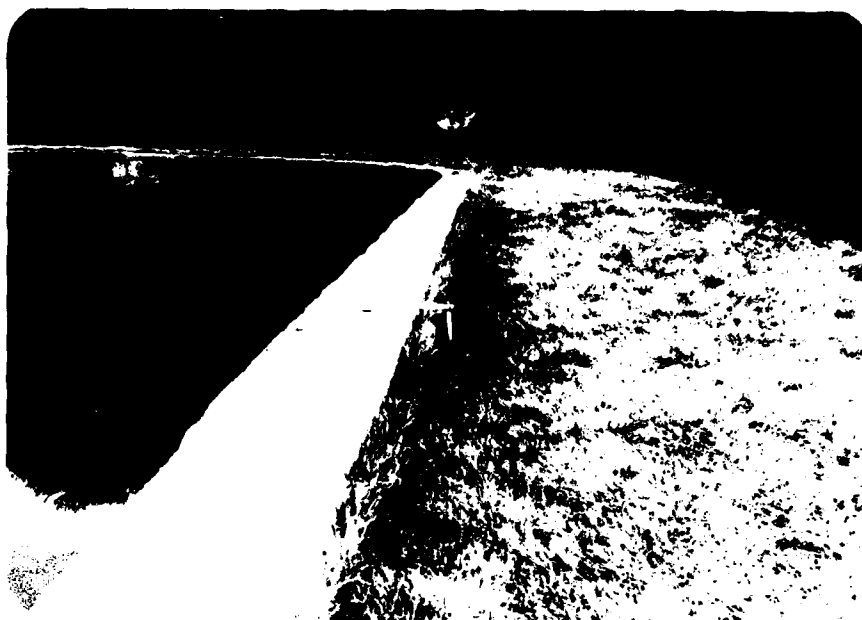
PHOTO NO. 3

UPSTREAM CONCRETE WALL AND CREST.
NOTE POSSIBLE SETTLEMENT OF EMBANKMENT
AND GRASS COVER ON CREST.

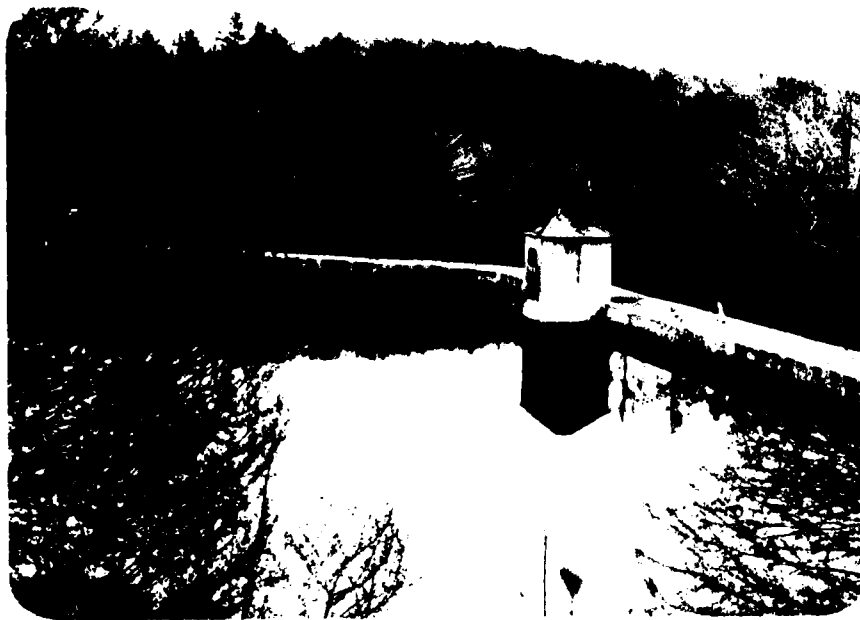
PHOTO NO. 11

GATEHOUSE
